Project No.  
**2655.002.023**

July 1, 2024

Subject: Bellavista Development  
Subdivision 9330  
Moraga, California

## MORAGA GEOLOGIC HAZARD ABATEMENT DISTRICT MONITORING – SPRING 2024

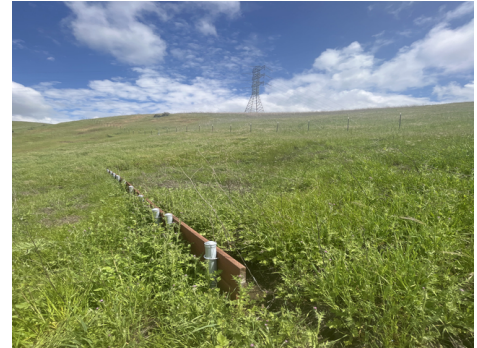
An existing landslide was observed along the Bellavista Trail (eastern boundary of Parcel A) and measured approximately 35 feet in width, 60 feet in length, and up to approximately 5 feet in depth (Site Condition A.1, Appendix A, Figure 1). The Developer constructed a 2-foot-high debris wall across the middle portion of the landslide to stabilize the earthflow. The debris wall was performing as designed at the time of this monitoring event. The GHAD will continue to monitor this earth movement and performance of the debris wall in future monitoring events.

Site Condition: A.1  
Observation Date: 04/12/2024  
Description: Shallow landslide along Trail (35 feet wide by 60 feet long with an estimated depth of up to 5 feet). Debris fence performing well.  
Recommendation: Continue to monitor.  
Field Representative: LR

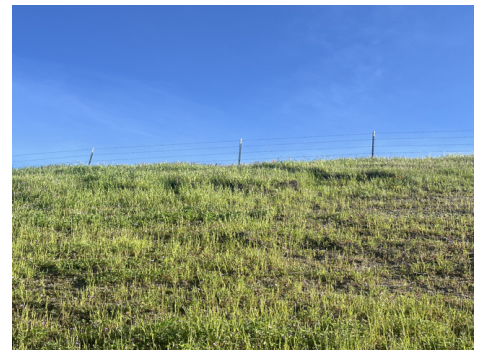
After the 2022-2023 winter season, we observed a surficial landslide approximately 15 feet north of Fay Hill Road that measured approximately 20 feet in width, 15 feet in length, and up to 1 foot in depth (Site Condition A.2, Appendix A, Figure 1). Since the fall 2023 monitoring event, new fencing was installed at the top of the slope above Fay Hill Road. At the time of this monitoring event, the landslide did not appear to threaten the road or other property improvements.

Site Condition: A.2  
Observation Date: 04/12/2024  
Description: Surficial landslide measuring approximately 20' wide, 15' long and 1' deep.  
Recommendation: Continue to monitor.  
Field Representative: LR

The GHAD will continue to monitor this area and fence performance during scheduled site monitoring.

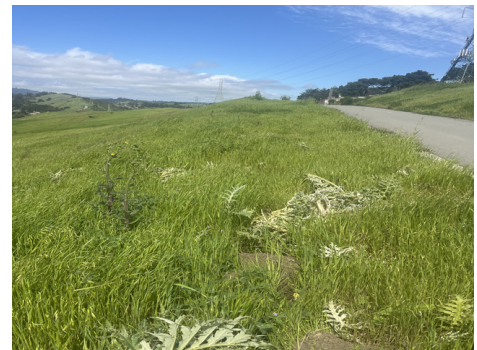
In the Fall 2022 monitoring event, we noted minor slope creep with significant surface desiccation and animal burrows adjacent to the EBMUD Reservoir access road (Site Condition B, Appendix A, Figure 1). At the time of this event, creep cracks and animal burrows were observed. Excessive animal burrows pose a risk to shallow slope stability in heavy rains; however, no areas of immediate concern were recognized as a threat to GHAD-maintained improvements at this time.

Site Condition: B  
Observation Date: 04/12/2024  
Description: Minor slope creep with surface desiccation and animal burrows adjacent to EBMUD Reservoir access road.  
Recommendation: Continue to monitor slope performance.  
Field Representative: LR

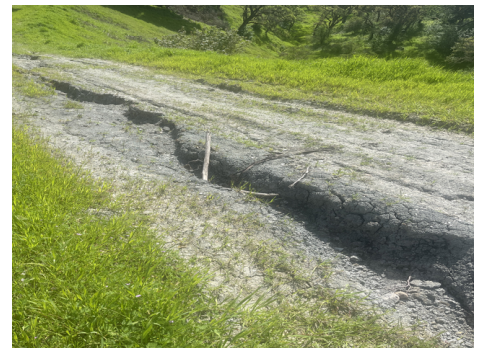
The emergency vehicle access/maintenance roadways (Figure 1) were checked for signs of distress. An erosional rill was identified along Fire Trail 42-8, up to 12" wide and 18" deep (Site Condition C, Appendix A, Figure 1). Moraga-Orinda Fire District (MOFD) will perform annual maintenance to maintain roadway access.

Site Condition: C  
Observation Date: 04/12/2024  
Description: Erosional rill on Fire Trail 42-8. 12" wide by 18" deep.  
Recommendation: Repair during annual maintenance.  
Field Representative: None

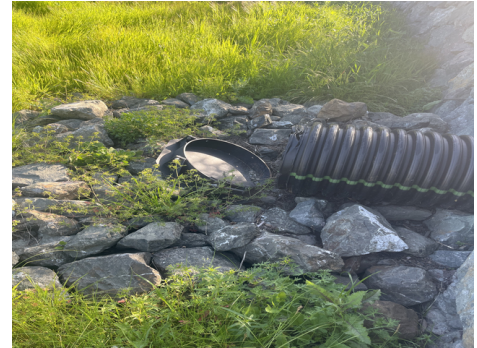
At the time of this monitoring event, a flap gate on an outfall pipe into Detention Basin B was broken off from the hinge point and detached from the pipe (Site Condition D, Appendix A, Figure 1). The flap gate should be repaired to allow for proper function.

Site Condition: D  
Observation Date: 04/12/2024  
Description: Broken flap gate on outfall pipe in Detention Basin B.  
Recommendation: Repair.  
Field Representative: LR
