Project No.  
**2655.002.024**

Subject: Bellavista Development  
Subdivision 9330  
Moraga, California

**MORAGA GEOLOGIC HAZARD ABATEMENT DISTRICT  
MONITORING – FALL 2024**

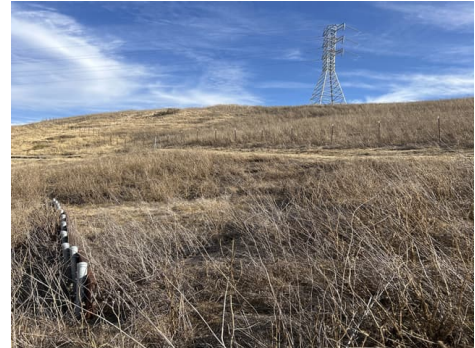
An existing landslide was observed along the Bellavista Trail (eastern boundary of Parcel A) and measured approximately 35 feet in width, 60 feet in length, and up to approximately 5 feet in depth (Site Condition A.1, Appendix A, Figure 1). The Developer constructed a 2-foot-high debris wall across the middle portion of the landslide to stabilize the earthflow. The debris wall was performing as designed at the time of this monitoring event. The GHAD will continue to monitor this earth movement and performance of the debris wall in future monitoring events.

Site Condition: A.1  
Observation Date: 10/25/2024  
Description: Shallow landslide along Trail (35 feet wide by 60 feet long with an estimated depth of up to 5 feet). Debris fence performing well.  
Recommendation: Continue to monitor.  
Field Representative: EW

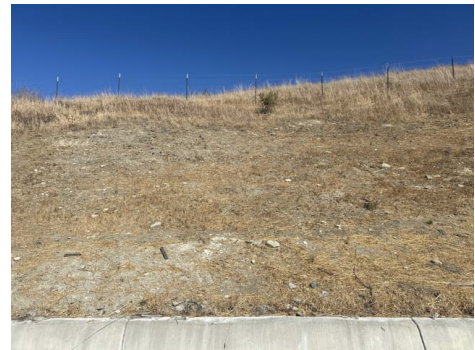
After the 2022-2023 winter season, we observed a surficial landslide approximately 15 feet north of Fay Hill Road that measured approximately 20 feet in width, 15 feet in length, and up to 1 foot in depth (Site Condition A.2, Appendix A, Figure 1). Since the Fall 2023 monitoring event, new fencing was installed at the top of the slope above Fay Hill Road. At the time of the Spring 2024 site-monitoring event, the shallow landslide was covered in natural vegetation and had not activated or increased in dimensions, and did not appear to threaten the road or other property improvements. This landslide remained unchanged at the time of this monitoring event.

Site Condition: A.2  
Observation Date: 10/25/2024  
Description: Surficial landslide measuring approximately 20' wide, 15' long and 1' deep.  
Recommendation: Continue to monitor.  
Field Representative: EW

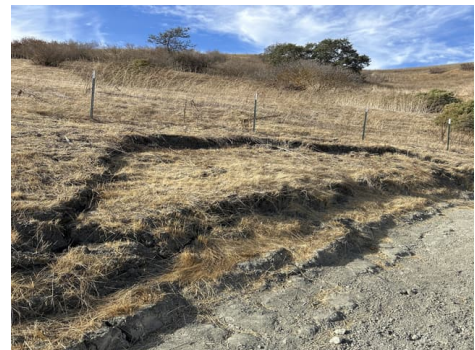
During this monitoring event, a surficial landslide was identified along Fire Trail 42-15, up to 15 feet in width, 10 feet in length, and approximately 1-2 feet in depth (Site Condition A.3, Appendix A, Figure 1). At the time of this monitoring event, road access was not significantly impacted and the MOFD will continue to maintain the road as a part of their annual maintenance. The GHAD will continue to monitor this area during future monitoring events.

Site Condition: A.3  
Observation Date: 10/25/2024  
Description: Shallow surficial landslide, 15 feet wide by 10 feet long. Approximately 1 foot deep.  
Recommendation: Continue to monitor.  
Field Representative: EW

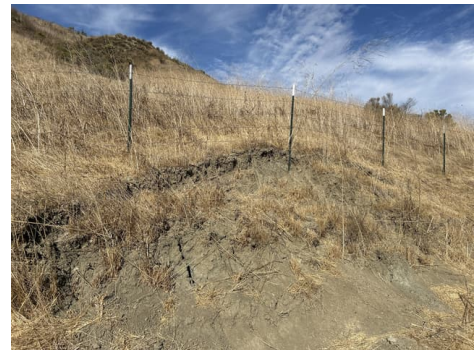
Site Condition: B  
Observation Date: 10/25/2024  
Description: Surficial slope erosion.  
Recommendation: Continue to monitor.  
Field Representative: EW
