Project No.  
**2655.002.025**

Subject: Bellavista Development  
Subdivision 9330  
Moraga, California

## **MORAGA GEOLOGIC HAZARD ABATEMENT DISTRICT MONITORING SPRING 2026**

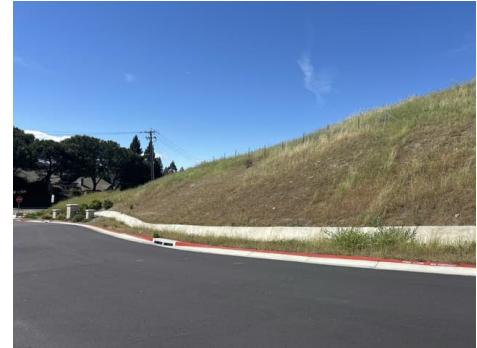
After the 2022-2023 winter season, we observed a surficial landslide approximately 15 feet north of Fay Hill Road that measured approximately 20 feet in width, 15 feet in length, and up to 1 foot in depth (Site Condition A.1, Appendix A, Figure 1). Since the fall 2023 monitoring event, new fencing was installed at the top of the slope above Fay Hill Road. At the time of the spring 2025 site-monitoring event, the shallow landslide was covered in natural vegetation and had not activated or increased in dimensions and did not appear to threaten the road or other property improvements. At the time of the spring 2026 monitoring event, the condition of this landslide remained unchanged. The GHAD will continue to monitor the condition of the slope during future monitoring events.

Site Condition: A.1  
Observation Date: 04/09/2026  
Description: Shallow surficial landslide (approximately 20 feet wide, 15 feet long and 1 foot deep). Appears to be revegetated.  
Recommendation: Continue to monitor.  
Field Representative: EW

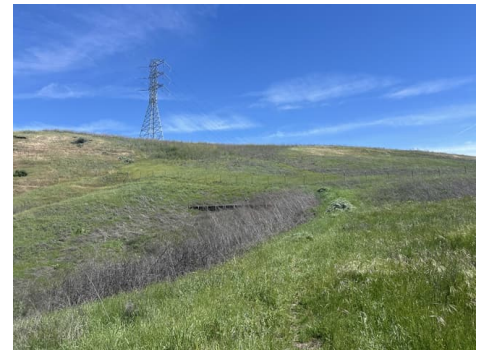
An existing landslide was observed along the Bellavista Trail (eastern boundary of Parcel A) and measured approximately 35 feet in width, 60 feet in length, and up to approximately 5 feet in depth (Site Condition A.2, Appendix A, Figure 1). The Developer constructed a 2-foot-high debris wall across the middle portion of the landslide to stabilize the earthflow. The debris wall was performing as designed at the time of this monitoring event. The GHAD will continue to monitor this earth movement and performance of the debris wall in future monitoring events and note in future monitoring reports if any changes are observed.

Site Condition: A.2  
Observation Date: 04/09/2026  
Description: Shallow landslide along Trail (35 feet wide by 60 feet long with an estimated depth of up to 5 feet). Debris fence performing well.  
Recommendation: Continue to Monitor  
Field Representative: EW

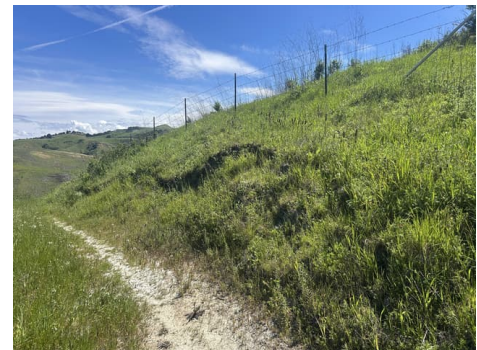
During the fall 2024 monitoring event, a surficial landside was identified along Fire Trail 42-15, measuring approximately 15 feet in width, 10 feet in length, and 1 foot in depth (Site Condition A.3, Appendix A, Figure 1). At the time of the Fall 2025 monitoring event, the depth of the landslide appeared to have increased to 1½ feet of depth. During this monitoring event, the landslide did not appear to have increased in depth, appeared to be fully vegetated, and road access was not significantly impacted. The MOFD will continue to maintain the road as part of their annual maintenance. The GHAD will continue to monitor the failed areas and note in future monitoring reports if any changes are observed.

Site Condition: A.3  
Observation Date: 04/09/2026  
Description: Shallow surficial landslide (estimated 15 feet wide by 10 feet long and approximately 1.5 feet deep).  
Recommendation: Continue to monitor.  
Field Representative: EW

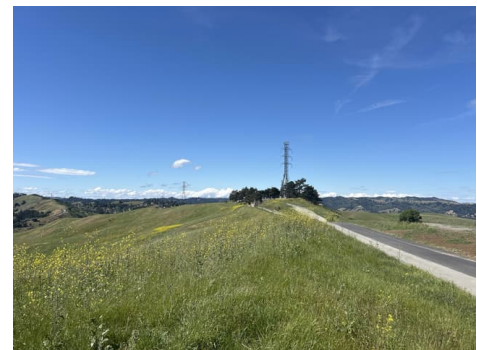
In the fall 2022 monitoring event, we first noted minor slope creep with significant surface desiccation and animal burrows adjacent to the EBMUD Reservoir access road. At the time of this monitoring event, the creep cracks and animal burrows were covered in vegetation and had not changed in dimension (Site Condition B, Appendix A, Figure 1). No areas of immediate

Site Condition: B  
Observation Date: 04/09/2026  
Description: Minor slope creep with surface desiccation and animal burrows adjacent to EBMUD Reservoir access road.  
Recommendation: Continue to monitor.  
Field Representative: EW

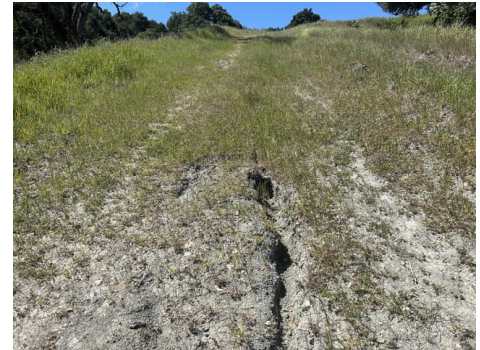
The emergency vehicle access/maintenance roadways (Figure 1) were checked for signs of distress. During this monitoring event, an erosional rill was identified along Fire Trail 42-8, up to 6 inches wide and 6 inches deep (Site Condition C, Appendix A, Figure 1). Moraga-Orinda Fire District (MOFD) will perform annual maintenance to maintain roadway access.

Site Condition: C  
Observation Date: 04/09/2026  
Description: Erosional rill along fire trail 42-8. 6" wide by 6" deep.  
Recommendation: Repair during annual maintenance.  
Field Representative: EW
