Project No.  
**2655.002.023**

July 1, 2024

Subject: Bellavista Development  
Subdivision 9330  
Moraga, California

## MORAGA GEOLOGIC HAZARD ABATEMENT DISTRICT MONITORING – SPRING 2024

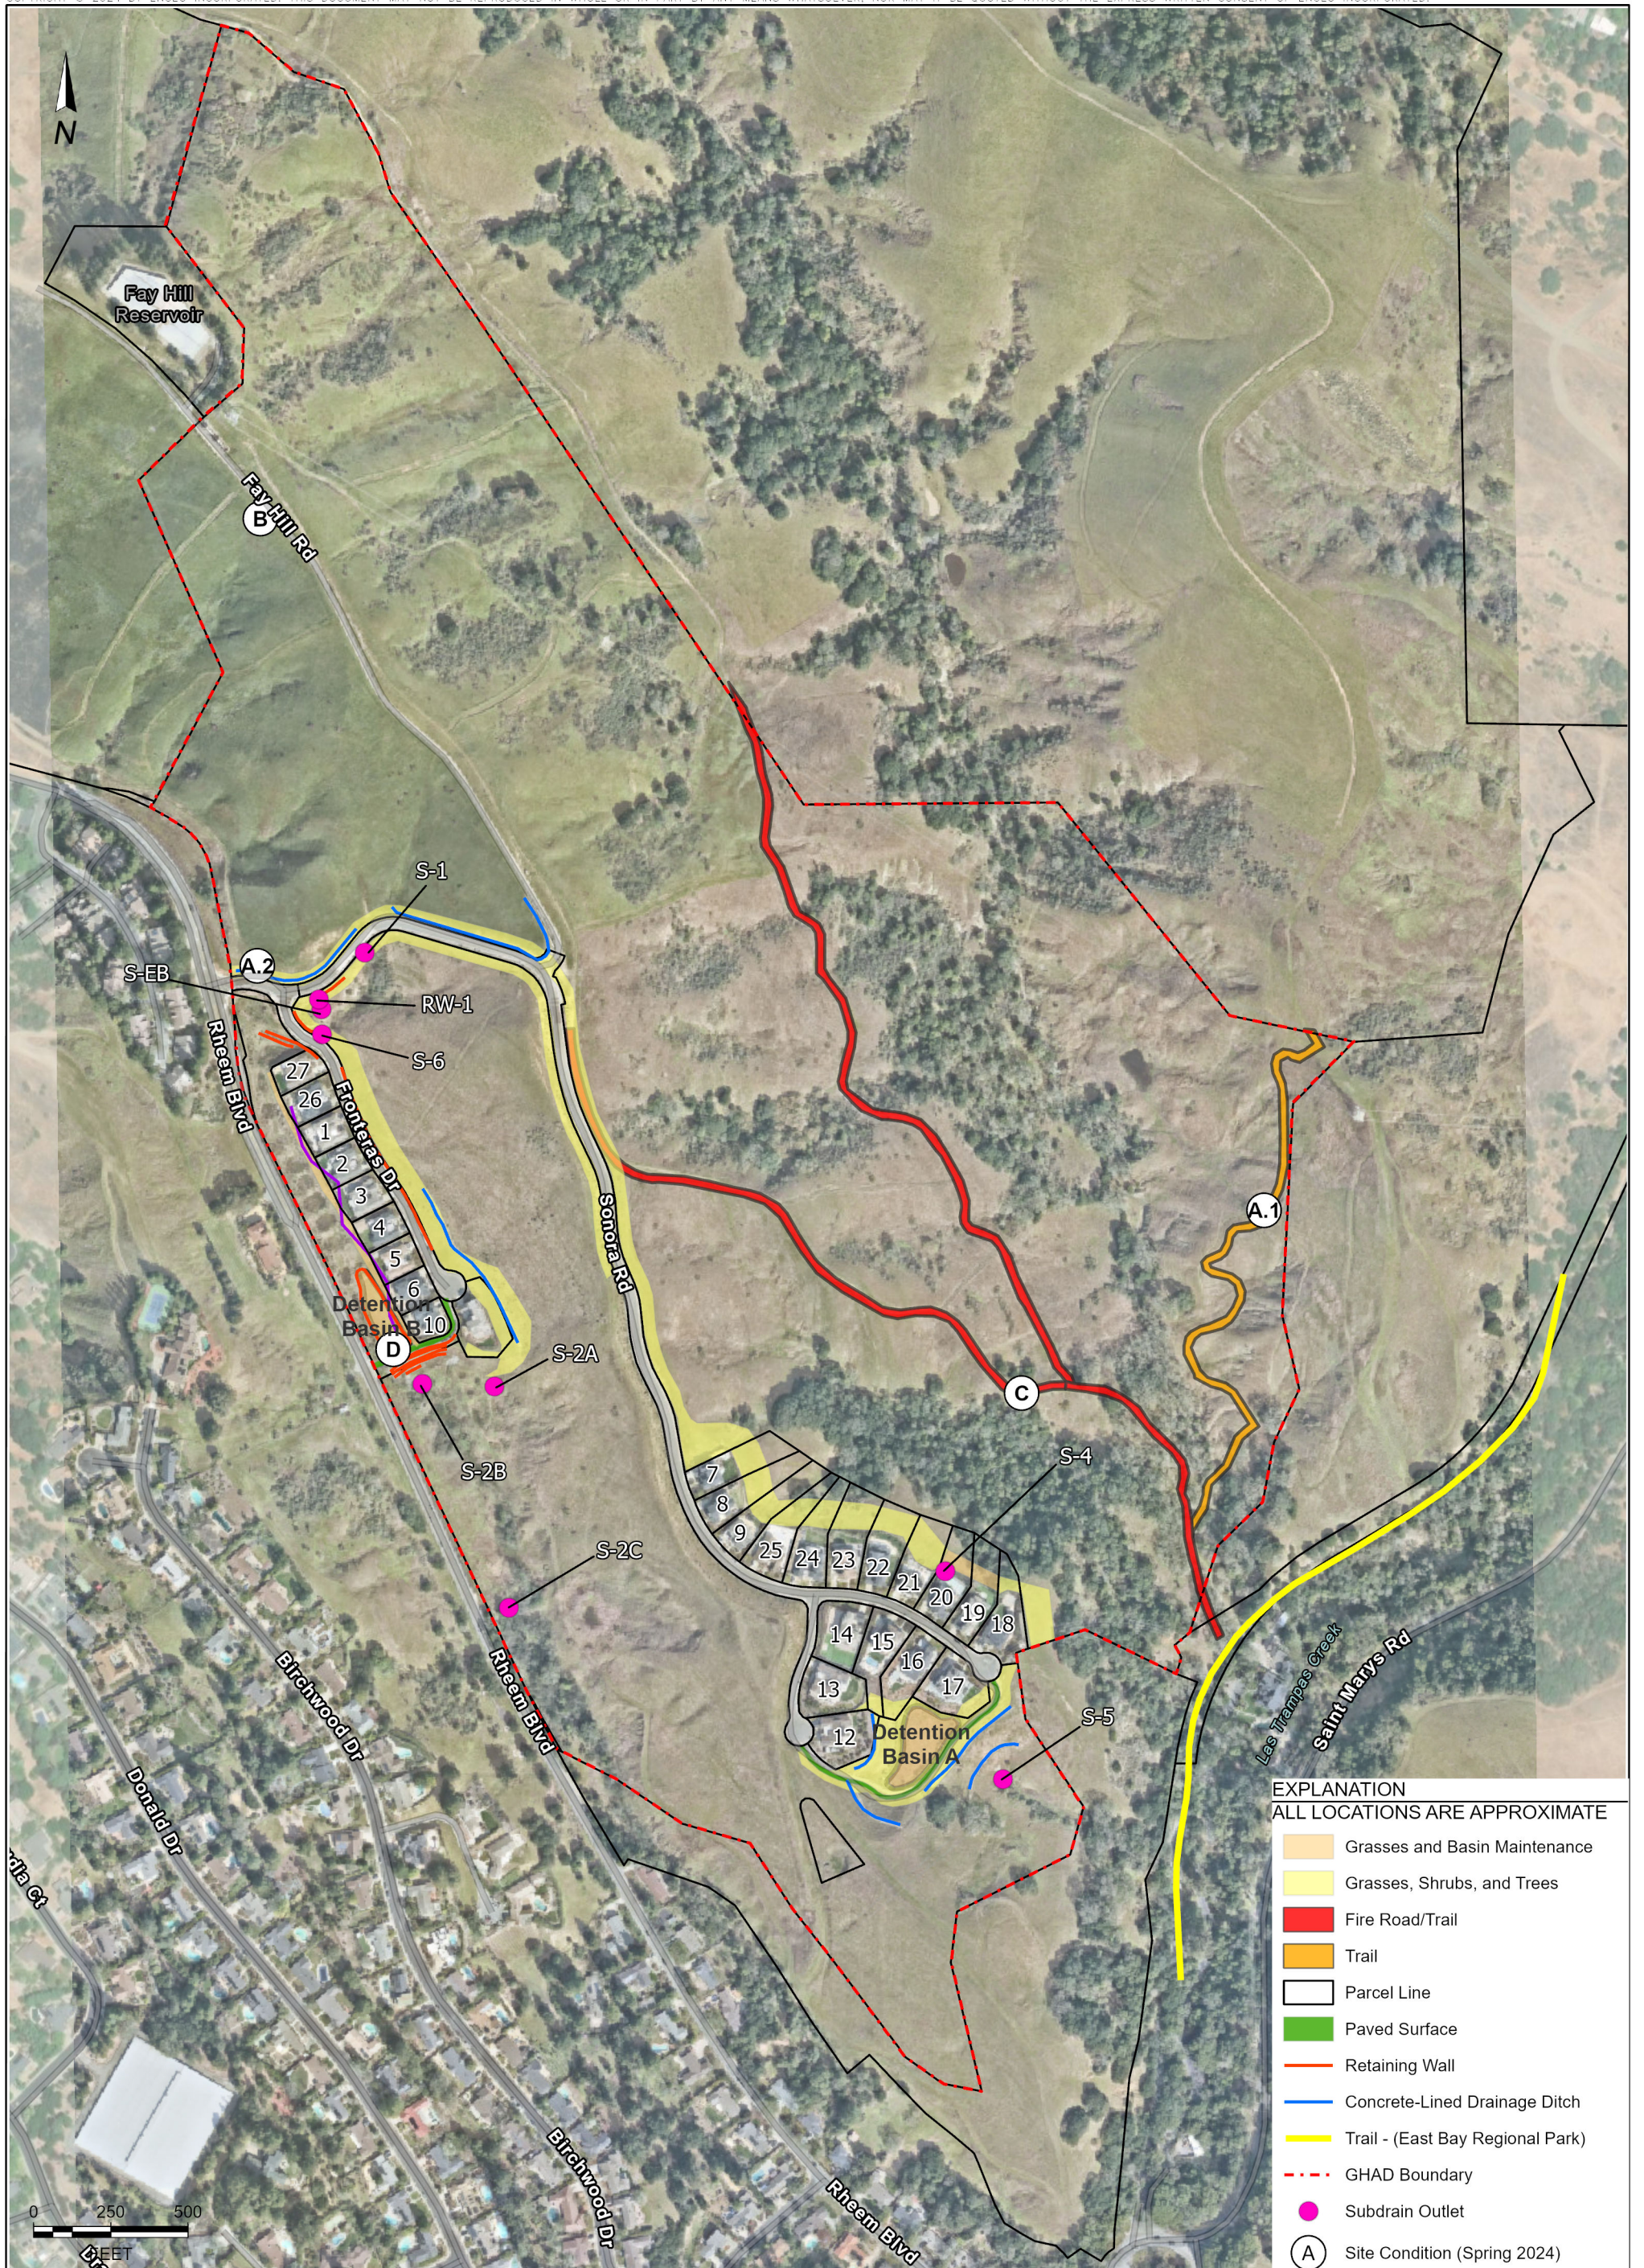
**FIGURE 1**

An existing landslide was observed along the Bellavista Trail (eastern boundary of Parcel A) and measured approximately 35 feet in width, 60 feet in length, and up to approximately 5 feet in depth (Site Condition A.1, Appendix A, Figure 1). The Developer constructed a 2-foot-high debris wall across the middle portion of the landslide to stabilize the earthflow. The debris wall was performing as designed at the time of this monitoring event. The GHAD will continue to monitor this earth movement and performance of the debris wall in future monitoring events.

After the 2022-2023 winter season, we observed a surficial landslide approximately 15 feet north of Fay Hill Road that measured approximately 20 feet in width, 15 feet in length, and up to 1 foot in depth (Site Condition A.2, Appendix A, Figure 1). Since the fall 2023 monitoring event, new fencing was installed at the top of the slope above Fay Hill Road. At the time of this monitoring event, the landslide did not appear to threaten the road or other property improvements.

In the Fall 2022 monitoring event, we noted minor slope creep with significant surface desiccation and animal burrows adjacent to the EBMUD Reservoir access road (Site Condition B, Appendix A, Figure 1). At the time of this event, creep cracks and animal burrows were observed. Excessive animal burrows pose a risk to shallow slope stability in heavy rains; however, no areas of immediate concern were recognized as a threat to GHAD-maintained improvements at this time.

The emergency vehicle access/maintenance roadways (Figure 1) were checked for signs of distress. An erosional rill was identified along Fire Trail 42-8, up to 12" wide and 18" deep (Site Condition C, Appendix A, Figure 1). Moraga-Orinda Fire District (MOFD) will perform annual maintenance to maintain roadway access.

At the time of this monitoring event, a flap gate on an outfall pipe into Detention Basin B was broken off from the hinge point and detached from the pipe (Site Condition D, Appendix A, Figure 1). The flap gate should be repaired to allow for proper function.
