Project No.  
**2655.002.024**

Subject: Bellavista Development  
Subdivision 9330  
Moraga, California

**MORAGA GEOLOGIC HAZARD ABATEMENT DISTRICT  
MONITORING – FALL 2024**

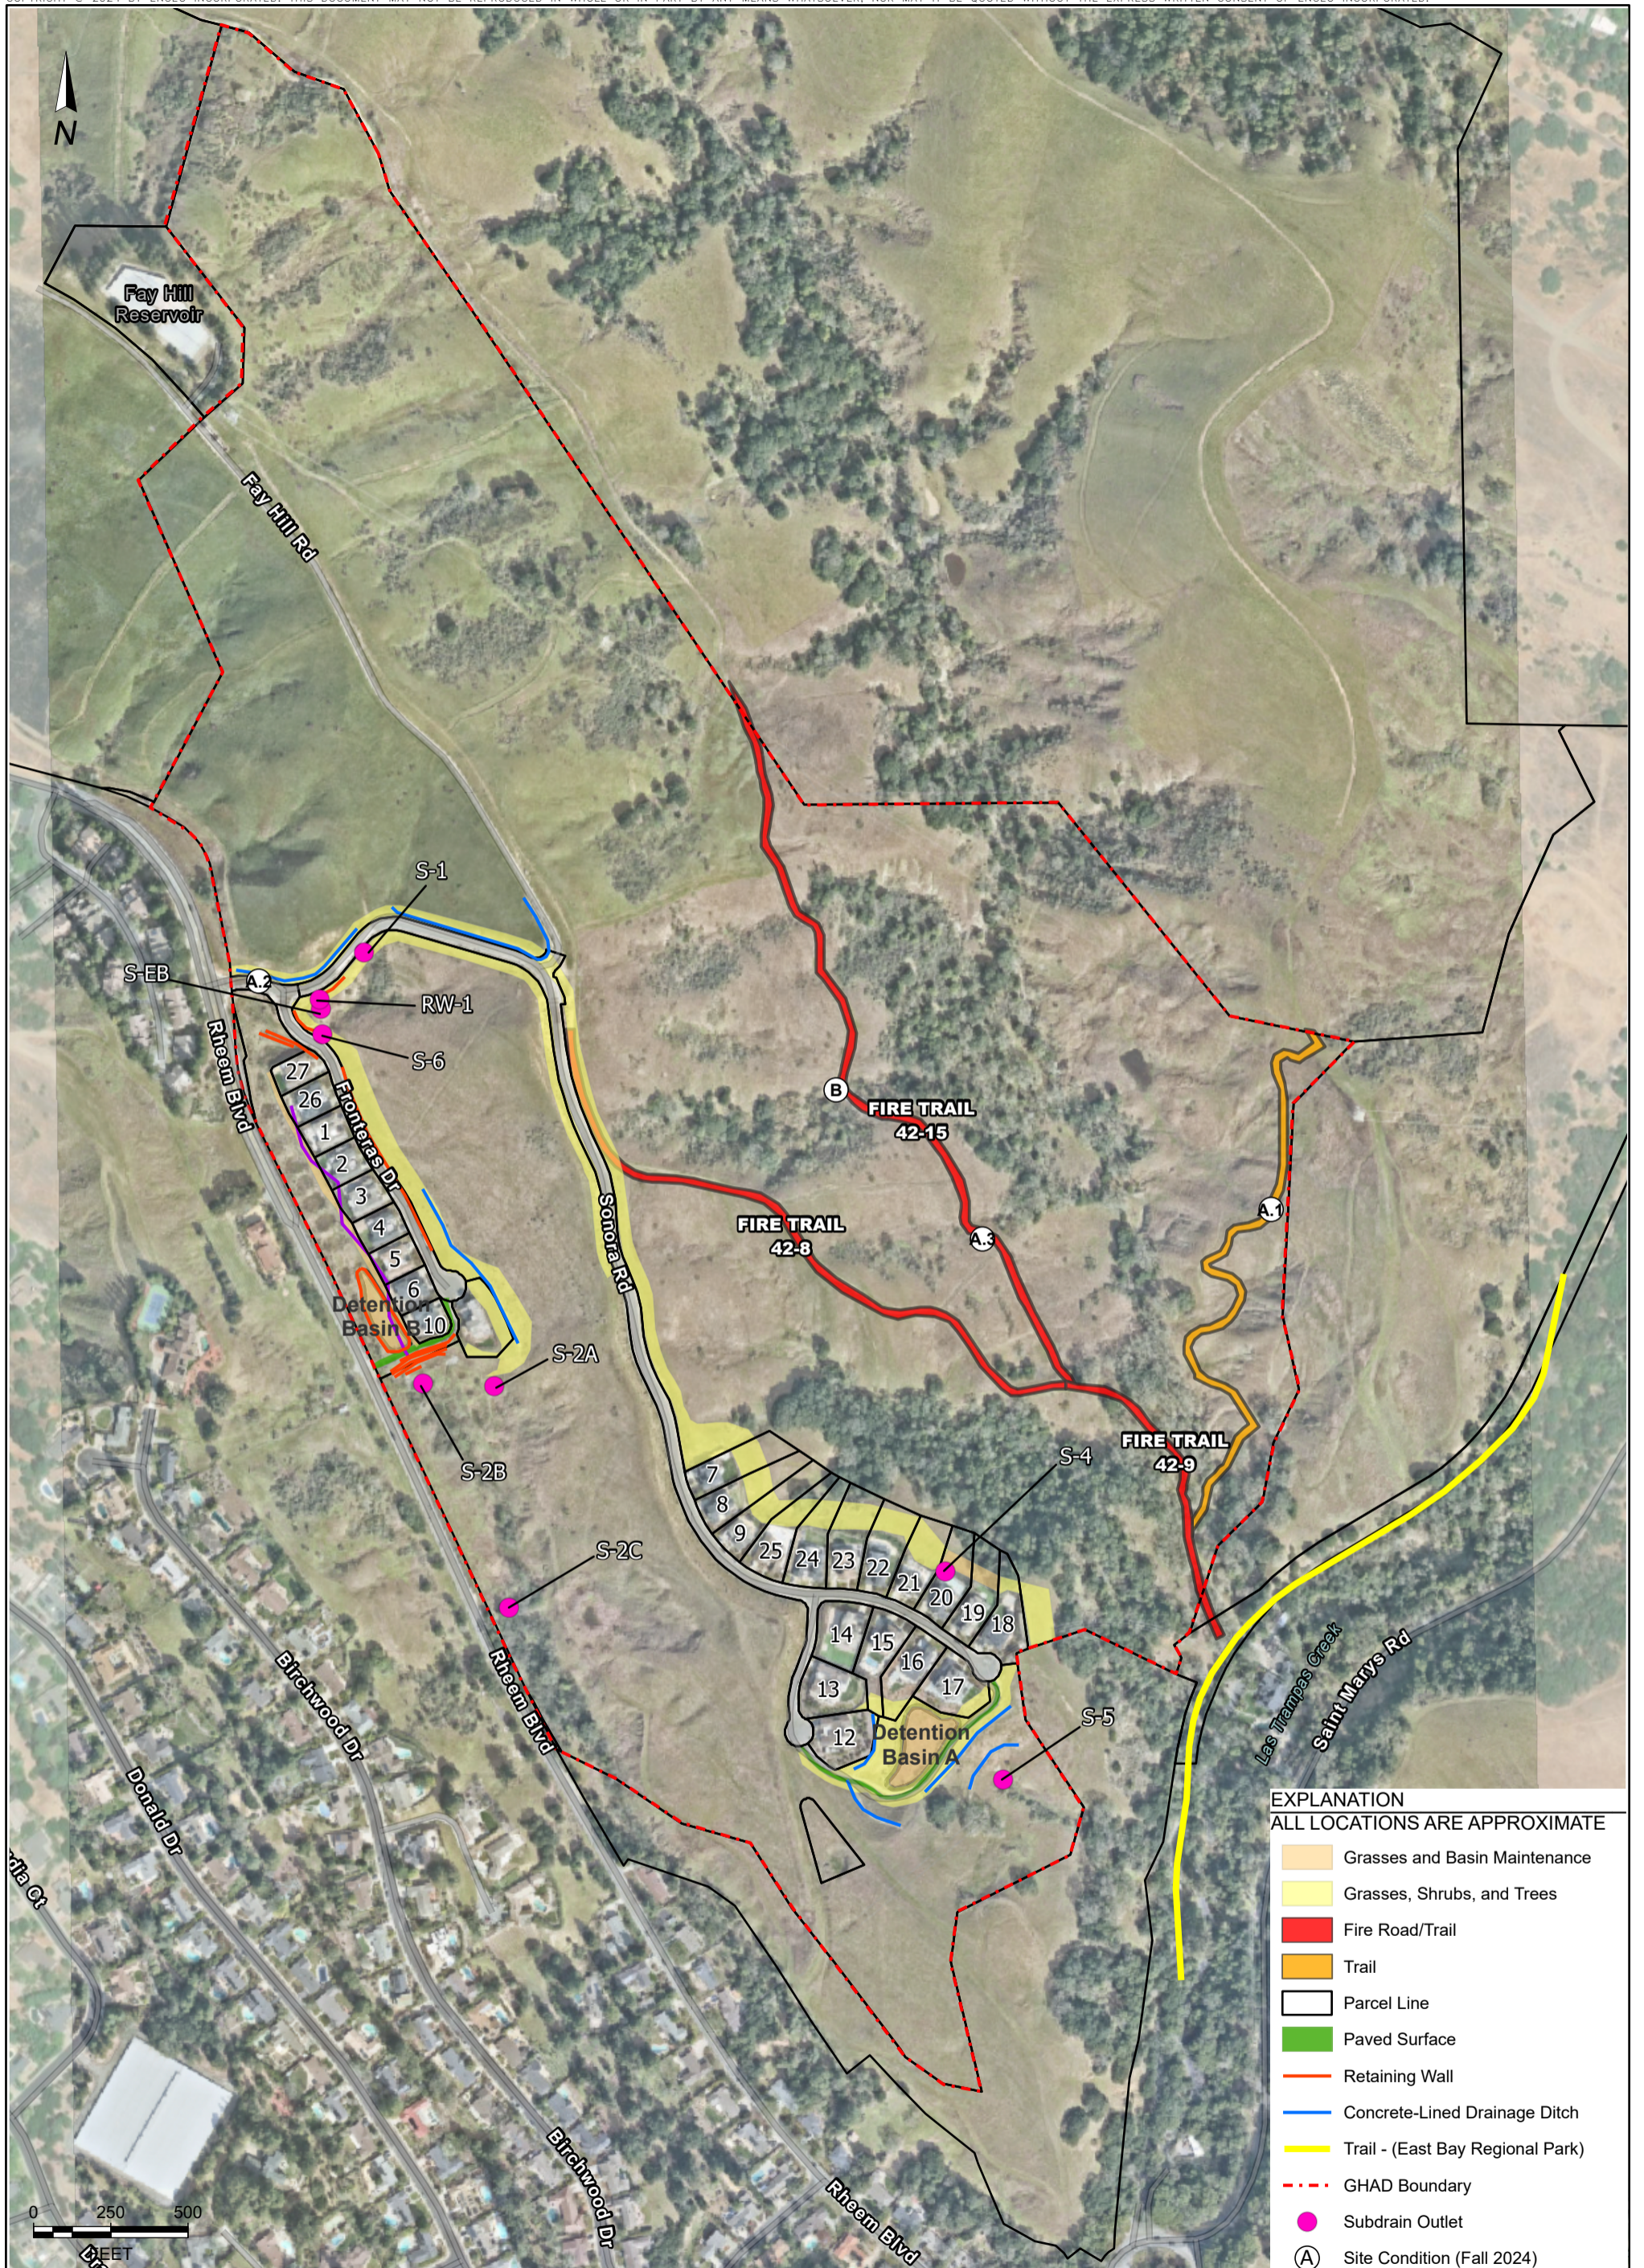
**FIGURE 1**

An existing landslide was observed along the Bellavista Trail (eastern boundary of Parcel A) and measured approximately 35 feet in width, 60 feet in length, and up to approximately 5 feet in depth (Site Condition A.1, Appendix A, Figure 1). The Developer constructed a 2-foot-high debris wall across the middle portion of the landslide to stabilize the earthflow. The debris wall was performing as designed at the time of this monitoring event. The GHAD will continue to monitor this earth movement and performance of the debris wall in future monitoring events.

After the 2022-2023 winter season, we observed a surficial landslide approximately 15 feet north of Fay Hill Road that measured approximately 20 feet in width, 15 feet in length, and up to 1 foot in depth (Site Condition A.2, Appendix A, Figure 1). Since the Fall 2023 monitoring event, new fencing was installed at the top of the slope above Fay Hill Road. At the time of the Spring 2024 site-monitoring event, the shallow landslide was covered in natural vegetation and had not activated or increased in dimensions, and did not appear to threaten the road or other property improvements. This landslide remained unchanged at the time of this monitoring event.

During this monitoring event, a surficial landslide was identified along Fire Trail 42-15, up to 15 feet in width, 10 feet in length, and approximately 1-2 feet in depth (Site Condition A.3, Appendix A, Figure 1). At the time of this monitoring event, road access was not significantly impacted and the MOFD will continue to maintain the road as a part of their annual maintenance. The GHAD will continue to monitor this area during future monitoring events.
