Project No.  
**2655.002.025**

Subject: Bellavista Development  
Subdivision 9330  
Moraga, California

## **MORAGA GEOLOGIC HAZARD ABATEMENT DISTRICT MONITORING SPRING 2026**

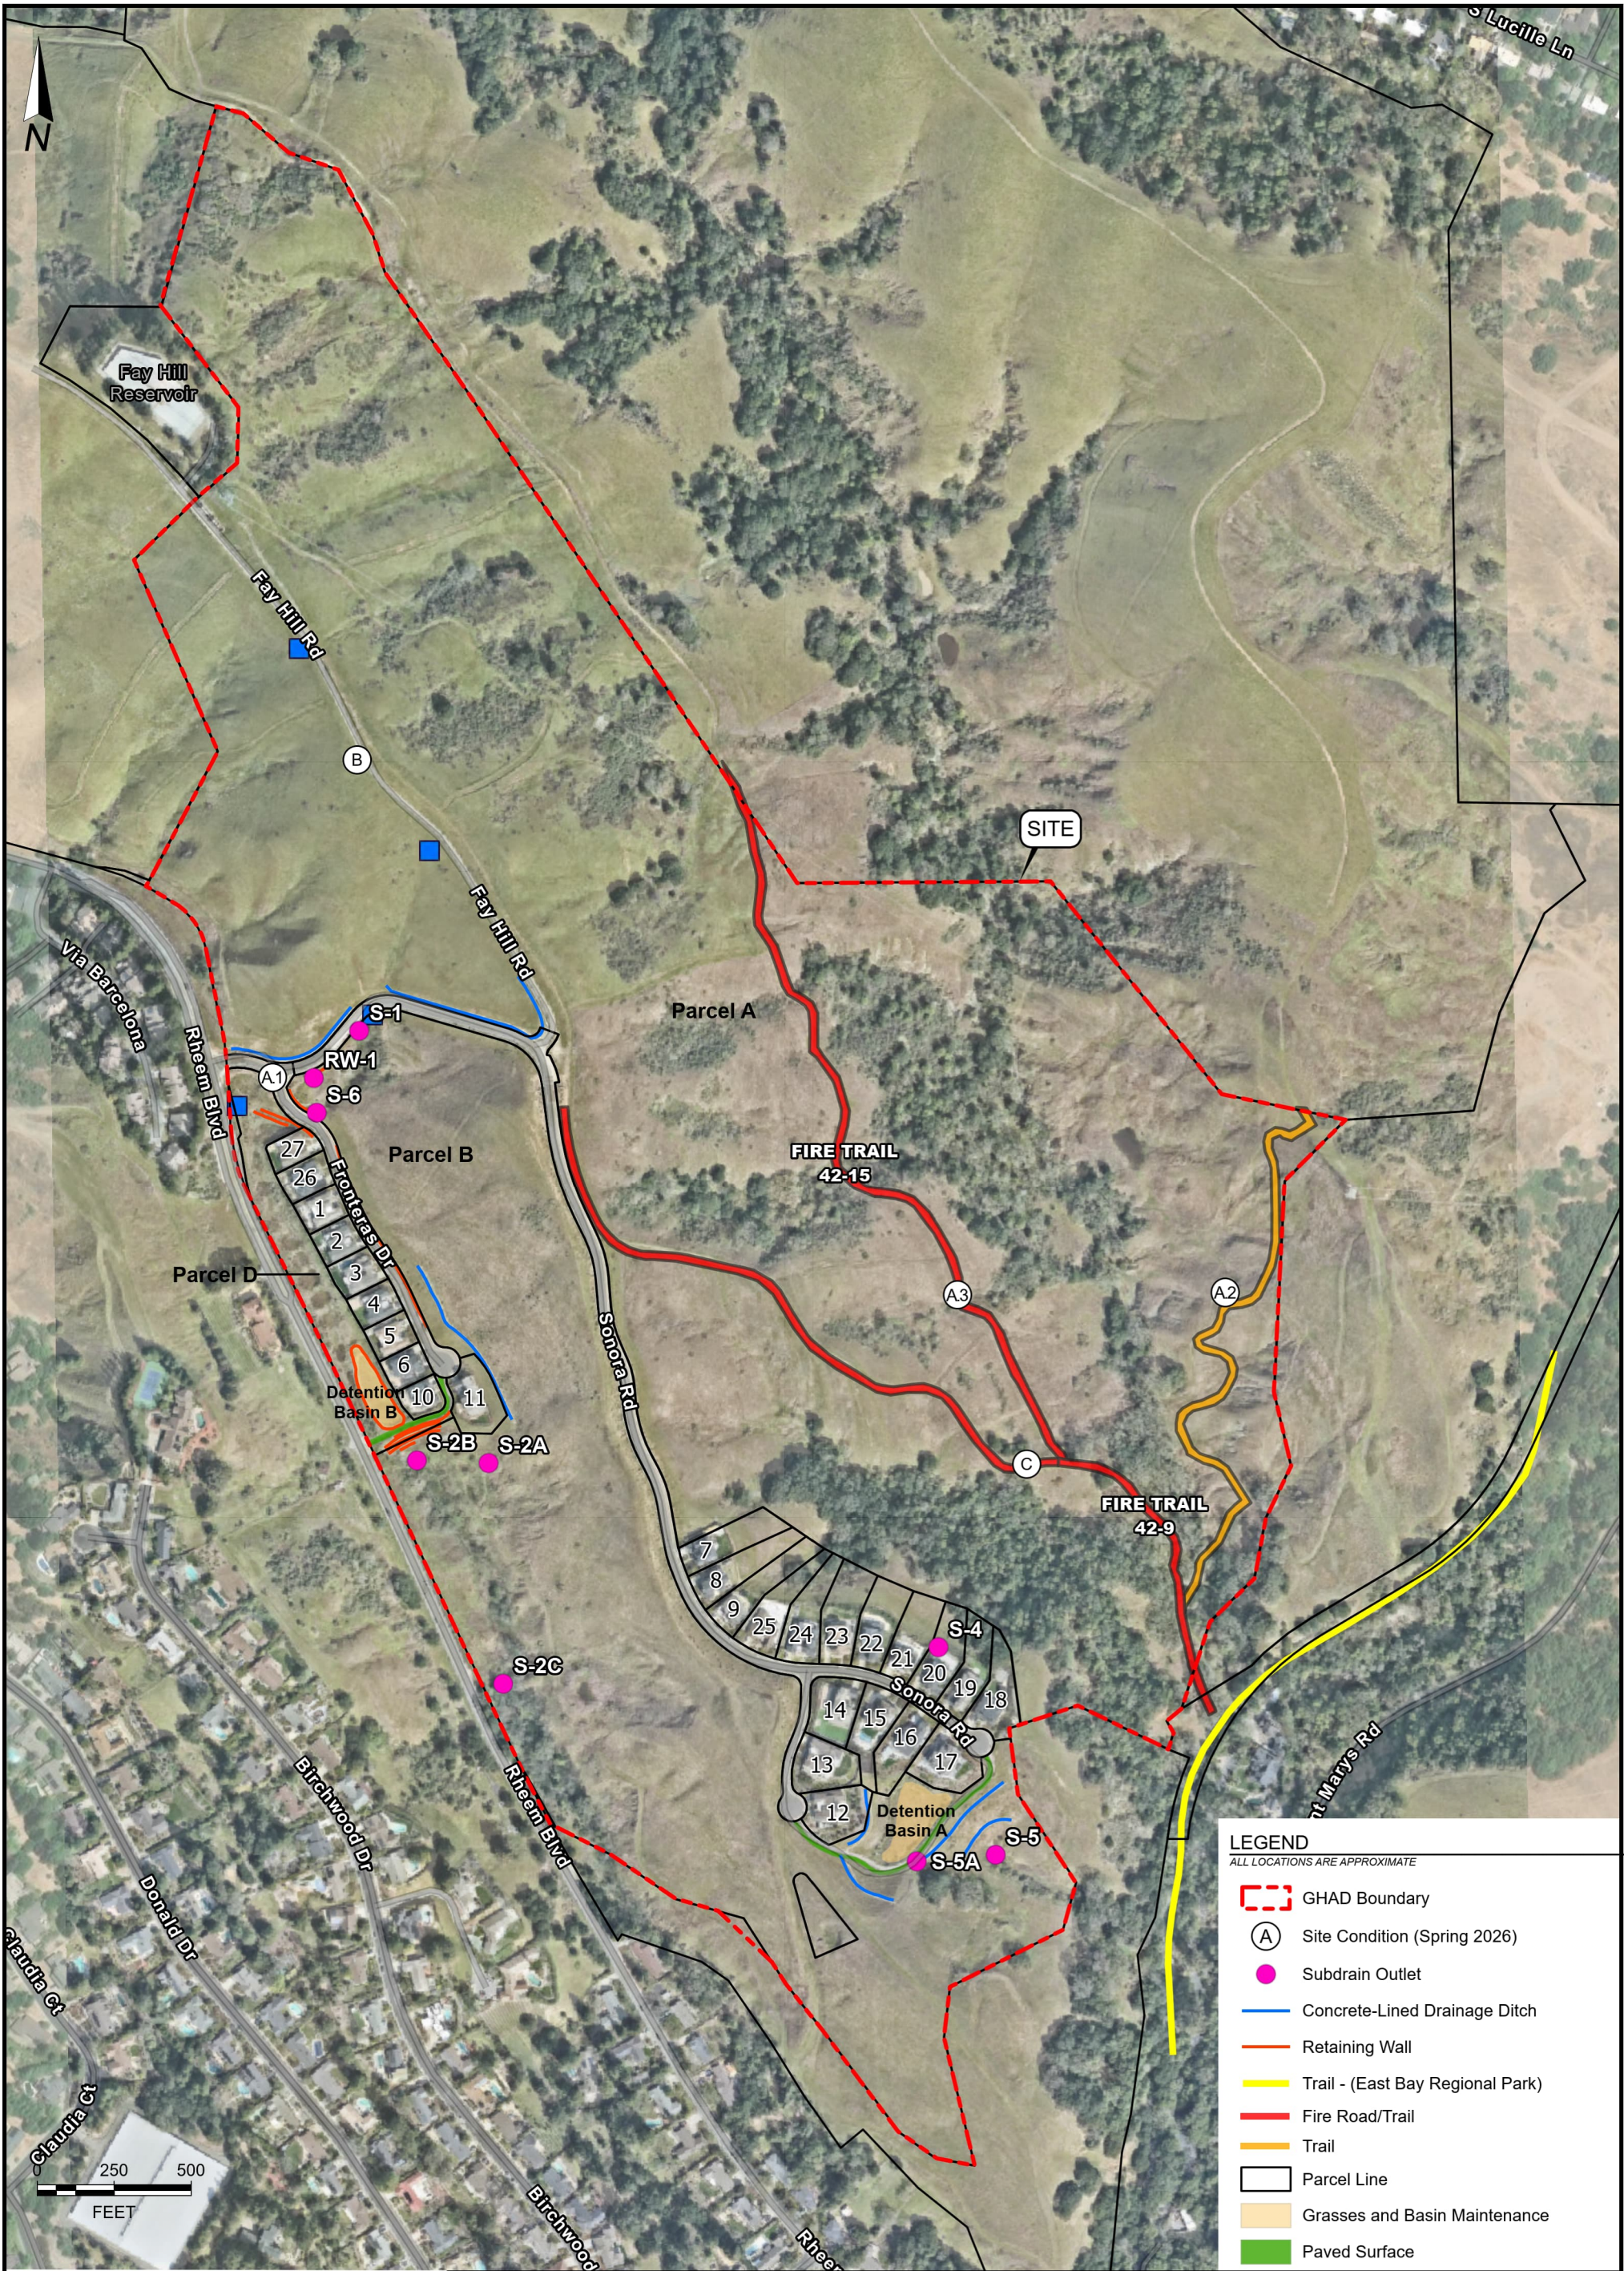
**FIGURE 1**

After the 2022-2023 winter season, we observed a surficial landslide approximately 15 feet north of Fay Hill Road that measured approximately 20 feet in width, 15 feet in length, and up to 1 foot in depth (Site Condition A.1, Appendix A, Figure 1). Since the fall 2023 monitoring event, new fencing was installed at the top of the slope above Fay Hill Road. At the time of the spring 2025 site-monitoring event, the shallow landslide was covered in natural vegetation and had not activated or increased in dimensions and did not appear to threaten the road or other property improvements. At the time of the spring 2026 monitoring event, the condition of this landslide remained unchanged. The GHAD will continue to monitor the condition of the slope during future monitoring events.

In the fall 2022 monitoring event, we first noted minor slope creep with significant surface desiccation and animal burrows adjacent to the EBMUD Reservoir access road. At the time of this monitoring event, the creep cracks and animal burrows were covered in vegetation and had not changed in dimension (Site Condition B, Appendix A, Figure 1). No areas of immediate

During the fall 2025 monitoring event, we observed multiple areas with surficial erosion along the slope adjacent to the west side of Fire Trail 42-15 (Figure 1). During this monitoring event, these areas were observed to be vegetated and unchanged. The GHAD will continue to monitor these areas and note, if needed, in future monitoring reports.

The emergency vehicle access/maintenance roadways (Figure 1) were checked for signs of distress. During this monitoring event, an erosional rill was identified along Fire Trail 42-8, up to 6 inches wide and 6 inches deep (Site Condition C, Appendix A, Figure 1). Moraga-Orinda Fire District (MOFD) will perform annual maintenance to maintain roadway access.

During the fall 2024 monitoring event, a surficial landside was identified along Fire Trail 42-15, measuring approximately 15 feet in width, 10 feet in length, and 1 foot in depth (Site Condition A.3, Appendix A, Figure 1). At the time of the Fall 2025 monitoring event, the depth of the landslide appeared to have increased to 1½ feet of depth. During this monitoring event, the landslide did not appear to have increased in depth, appeared to be fully vegetated, and road access was not significantly impacted. The MOFD will continue to maintain the road as part of their annual maintenance. The GHAD will continue to monitor the failed areas and note in future monitoring reports if any changes are observed.
